NATIONAL TRANSPORTATION SAFETY BOARD

Attachment 4 – Simulator and Cockpit Evaluation

DCA17FA021

Operator: American Airlines
Location: Chicago O'Hare International Airport (KORD), Chicago, Illinois
Date: October 28, 2016
Time: 1430 Central Daylight Time (CDT)
Airplane: Boeing 767-300, N345AN, SN 33084

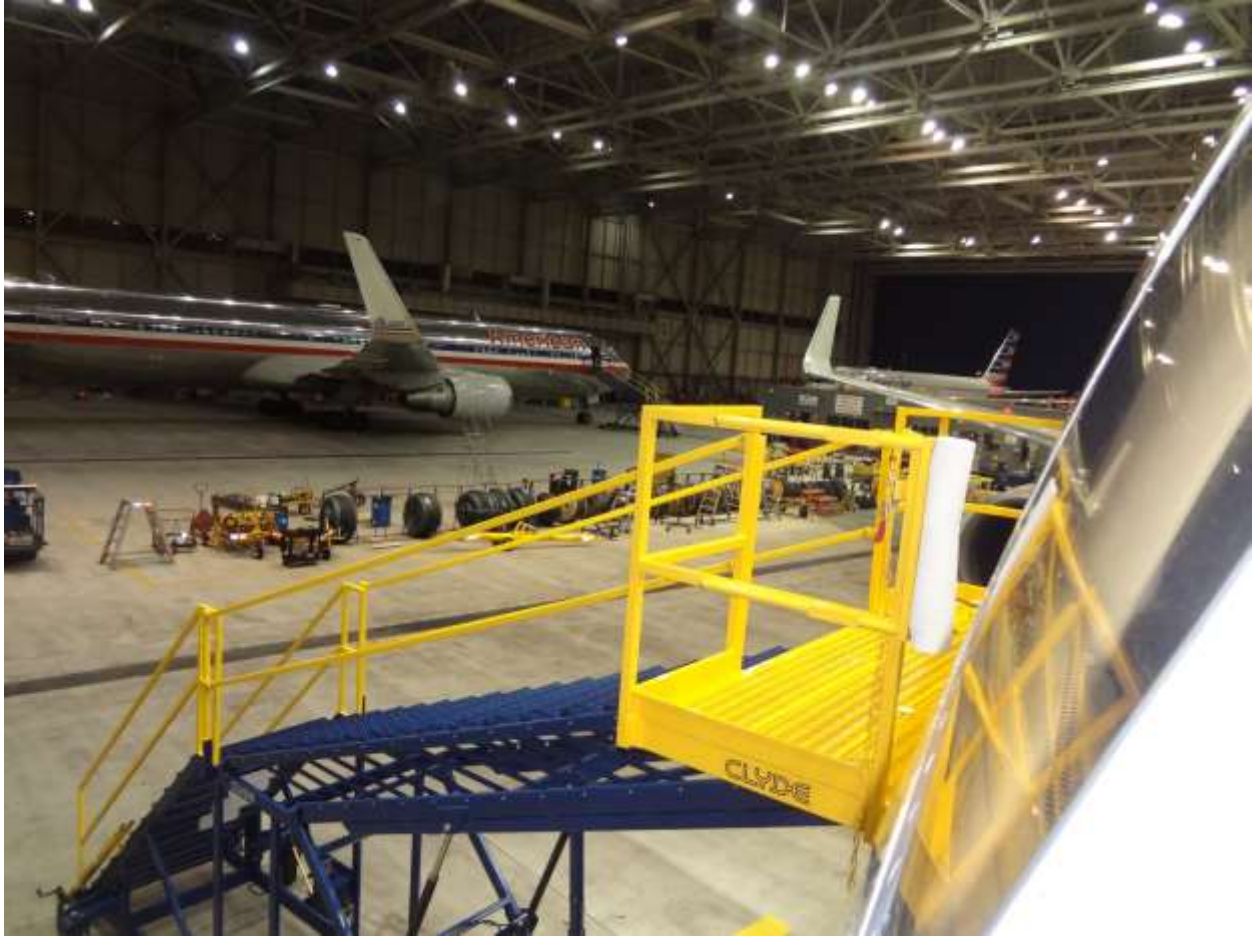
While seated in the first officer's seat in various seat positions, relative to the control column, the right wing tip was visible only when the occupant's head was pressed against the side cockpit window. With the right side cockpit window opened and with the field of vision shifted to approximately 8 inches outside the cockpit window the right engine was visible. For clarification, the right engine was not visible from within the cockpit with the windows closed and the right wingtip was visible from positions adjacent to the window.

Photo 1: View of Right Engine from approximately 8 inches outside right-hand cockpit window (OPS Group Chairman)

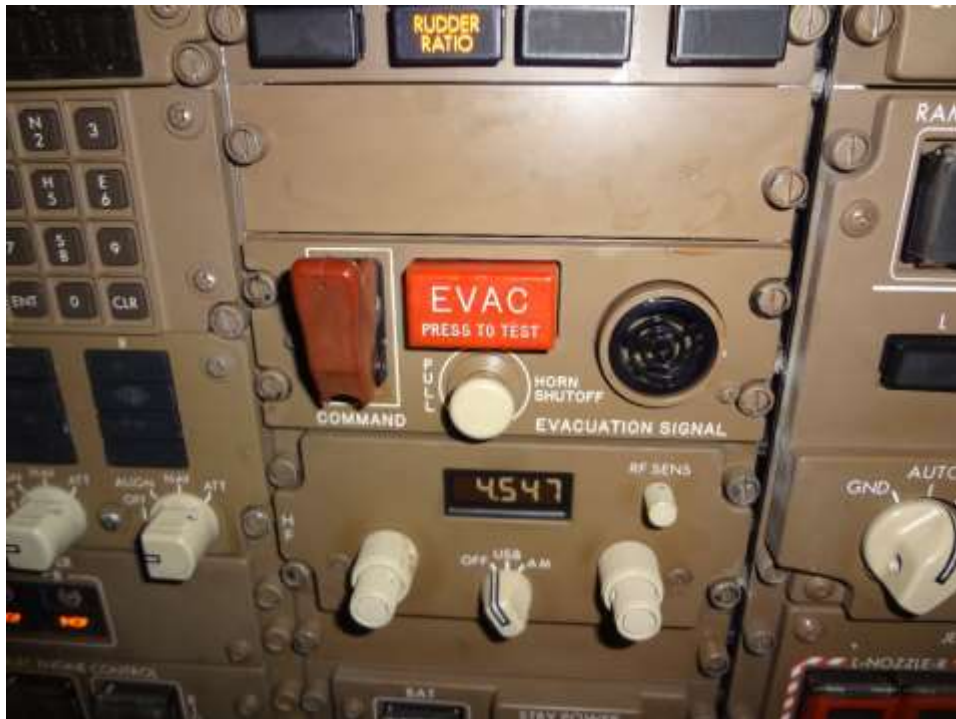
The overhead panel contained numerous lights and switches, including the evacuation switch, pressurization panel, cabin call lights, and entry door status light. During the evaluation, the evacuation switch was activated and the evacuation horn was audibly observed in the cockpit and the cabin. The horn was silenced, in the cockpit only, by pulling on the white “horn shutoff” switch located immediately to the right of the command switch.

Photo 2: Cockpit Evacuation Command Panel (OPS Group Chairman)

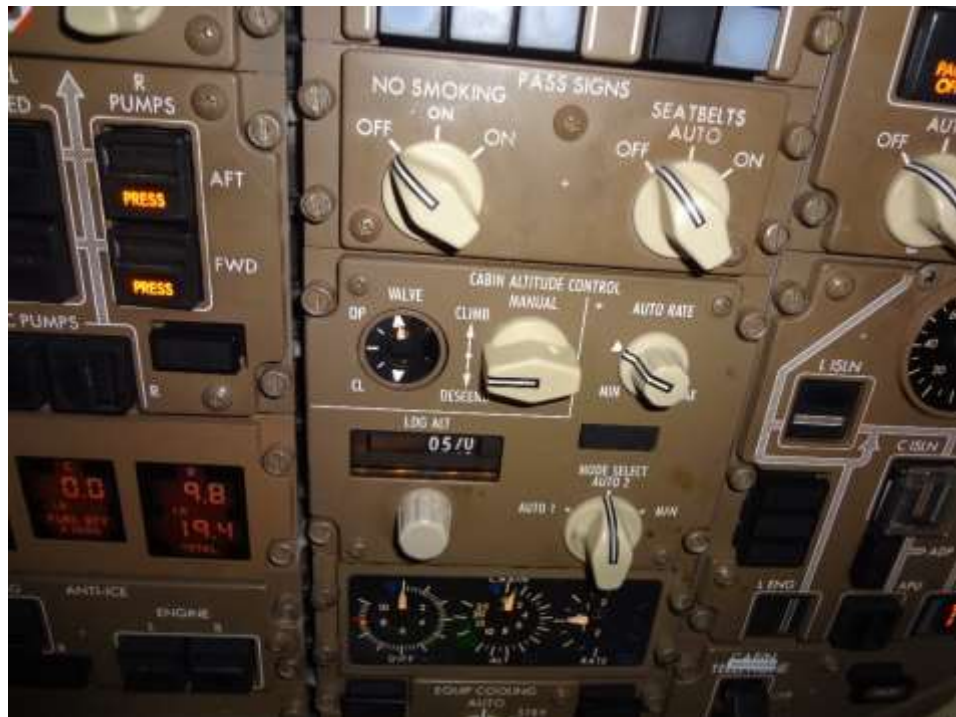
Photo 3: Cabin Altitude Control Panel (OPS Group Chairman)

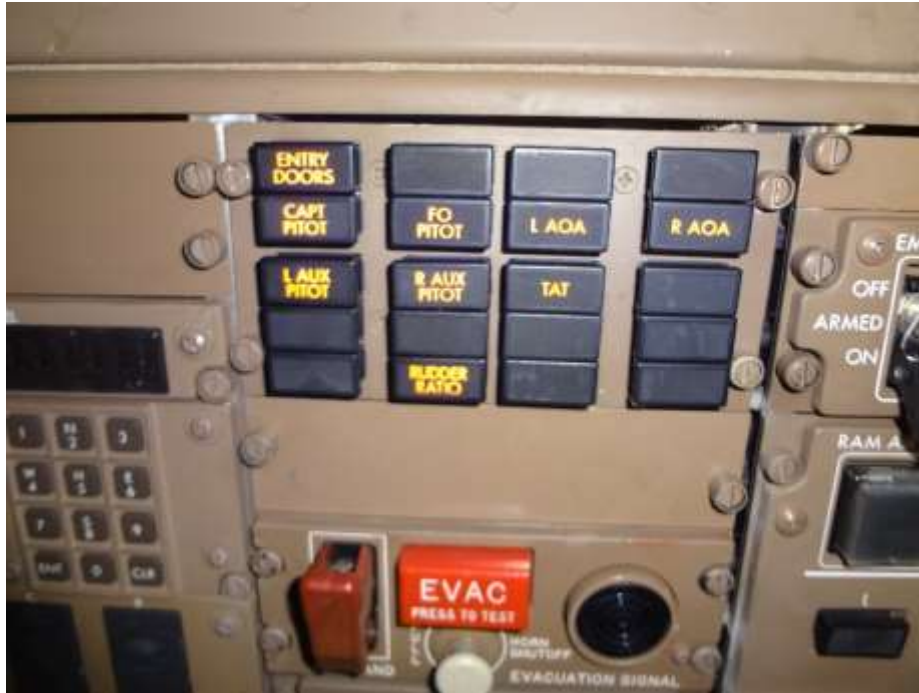
Photo 4: Entry Doors Status Indicator (OPS Group Chairman)

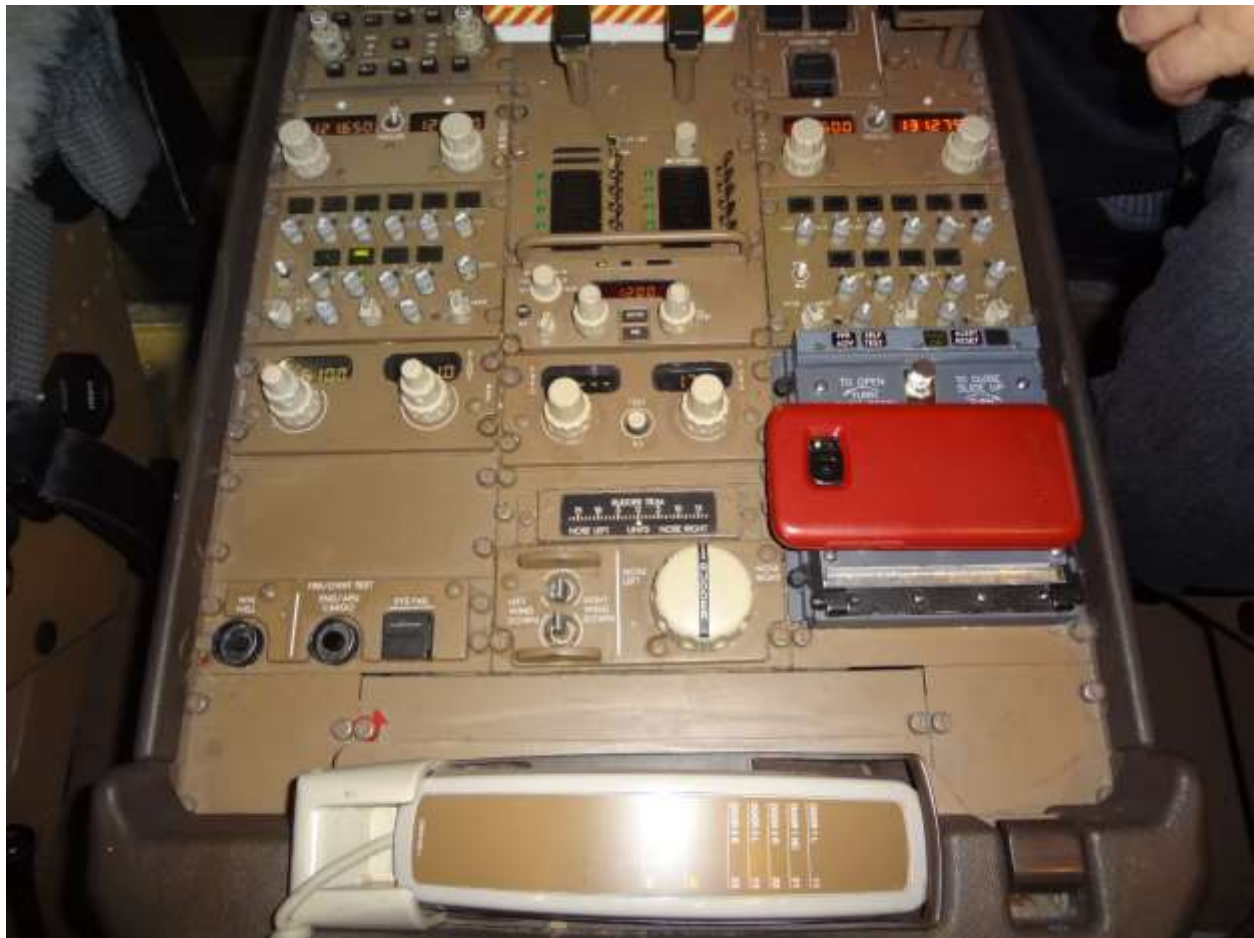
The group also tested the cockpit interphone handset. The handset consisted of a numerical keypad and a “reset” button located directly below the numerical keypad, when held with the numbers right side up. The handset also had a label affixed to it with seven preassigned two-digit numbers for various door stations, public address system, and a flight attendant alert. When the flight attendant alert two-digit number was entered, four-chimes were audibly detected in the cabin of the aircraft. It was also noted that following the dialing of any of the preset extensions the handset unit, the “RESET” button had to be depressed and released (or the interphone reseated in the cradle) in order to either redial the same extension, dial another extension, or make a public address to the cabin. It was also noted that the same occurred when attempting to contact the cockpit from a flight attendant station. The group utilized the door “1 L” handset and dialed the cockpit; however, in order to chime the cockpit numerous times in rapid succession the operator would have to press “RESET” between each attempt. The group also kept the door “1 L” handset out of the secure holder and attempted to contact the cockpit from the door “1 RC” station. In this

test, the chime was audibly observed in the cockpit. The group further made a public address to the cabin from the “1 L” handset and attempted to subsequently contact the cockpit from the door “1 RC” handset; however, no audible chime was observed in the cockpit.

Photo 5: Center Pedestal as viewed from the aft (OPS Group Chairman)

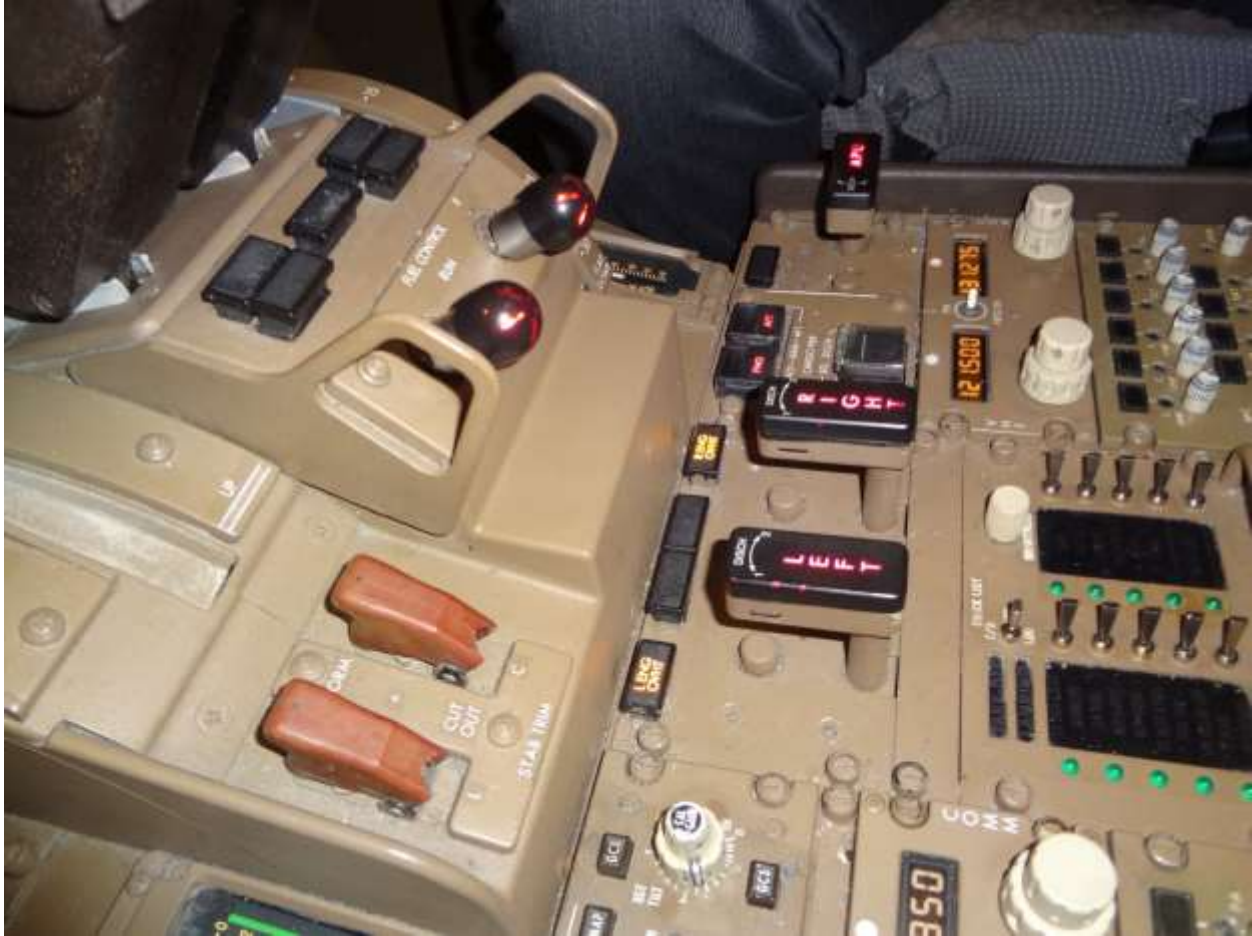
The center pedestal was located between the two pilot seats and contained various switches and system interaction, including the “FIRE/OVT TEST” panel, radio panel, radio tuning unit, Fuel Cutoff Switch, and the interphone handset. The group operated the “FIRE/OVT TEST” switch in order to test the firebell and the illuminated handles and switches. During the test the group observed the fire handle for the left and right engine, the APU firehandle, the Fuel Cutoff Switches for both engines, and the cargo firebottle “ARM” illuminate. During the test, the firebell was audibly detected and sounded once every approximate 5 seconds. During the fire test the group utilized the door “1 L” interphone to chime the cockpit. The interphone chime was audibly observed during the fire test and was able to be distinguished from the firebell.

Photo 6: Firehandles and Fuel Cutoff Switch during Fire Test as viewed from Captain's Seat (OPS Group Chairman)

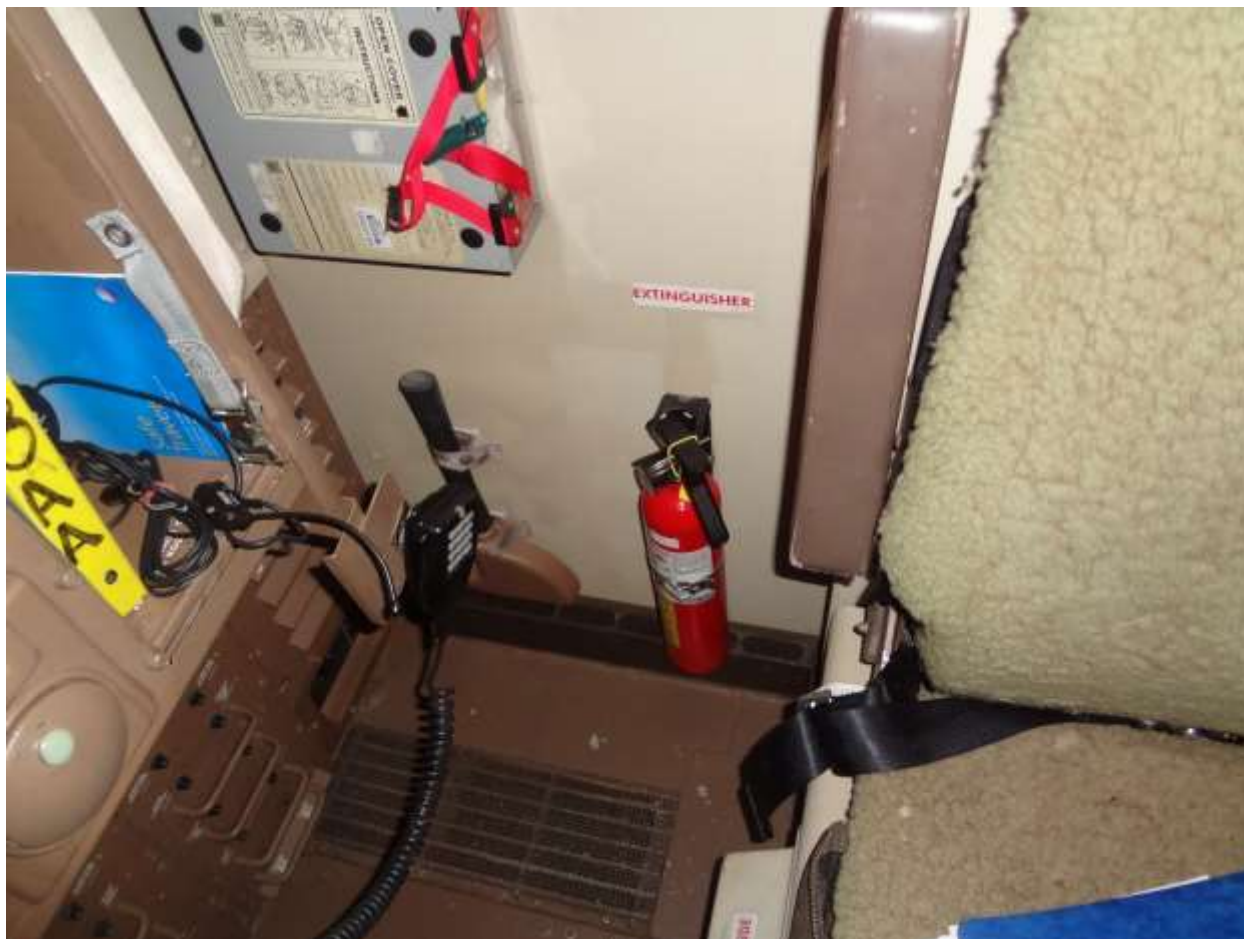
The group documented the emergency equipment available in the cockpit, as well as any other emergency equipment the flightcrew was responsible for using during an emergency. The cockpit fire extinguisher, crash axe, and PBE³ was located on the flight deck wall behind the first officer's seat and to the right of the cockpit jumpseat (when seated facing forward). The location was also immediately below the hat clips affixed to the wall for the pilot's hat. The megaphone was located in a cabinet, located in the forward galley. The cabinet door consisted of four other placards besides the megaphone placard. When the cabinet door was opened, various emergency and flotation equipment were observed. Removal of some of the equipment revealed the megaphone mounted on and towards the aft of a metal shelf frame that was mounted in the cabinet.

Photo 7: Cockpit Emergency Equipment (OPS Group Chairman)

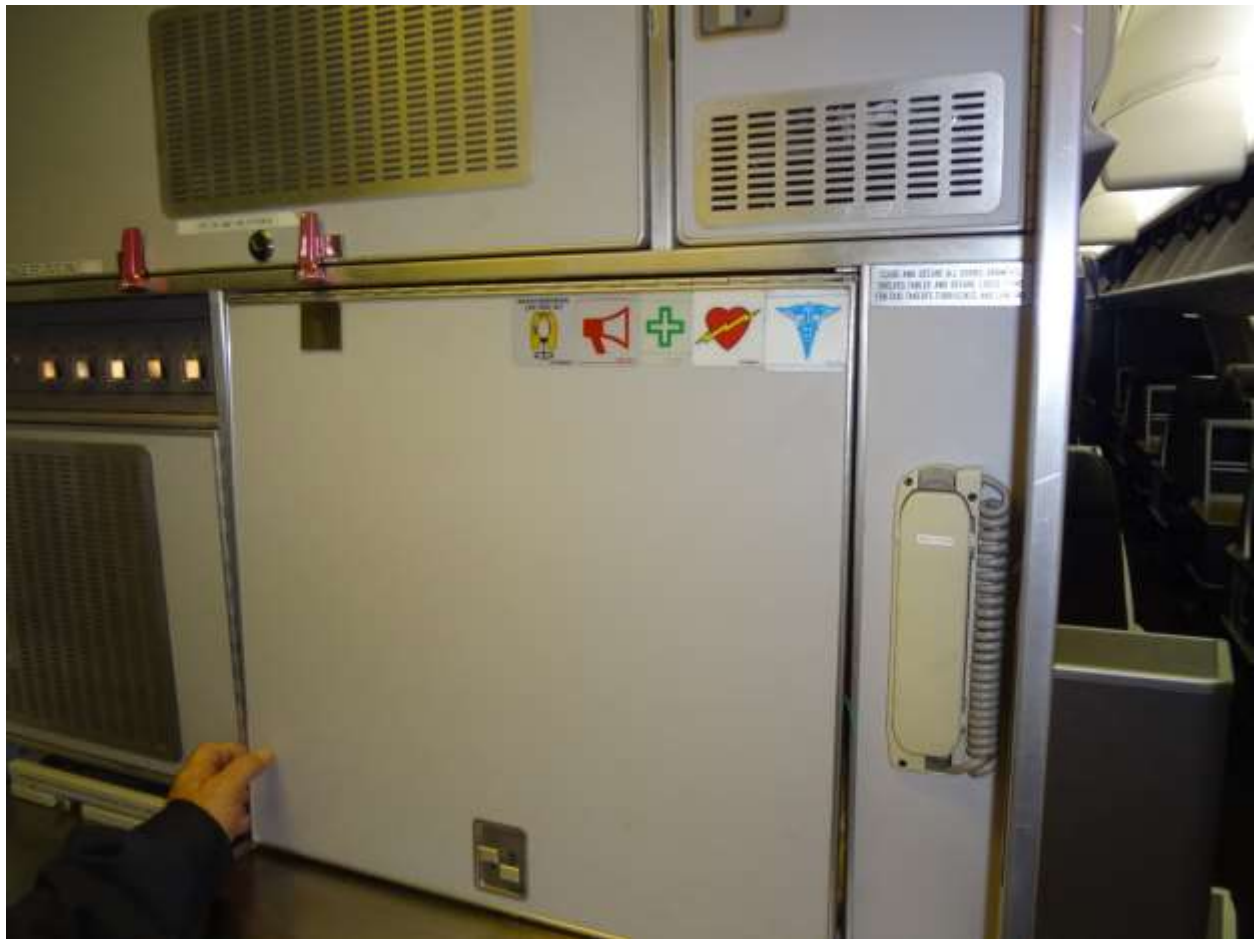
Photo 8: Forward Galley Emergency Equipment Cabinet (OPS Group Chairman)

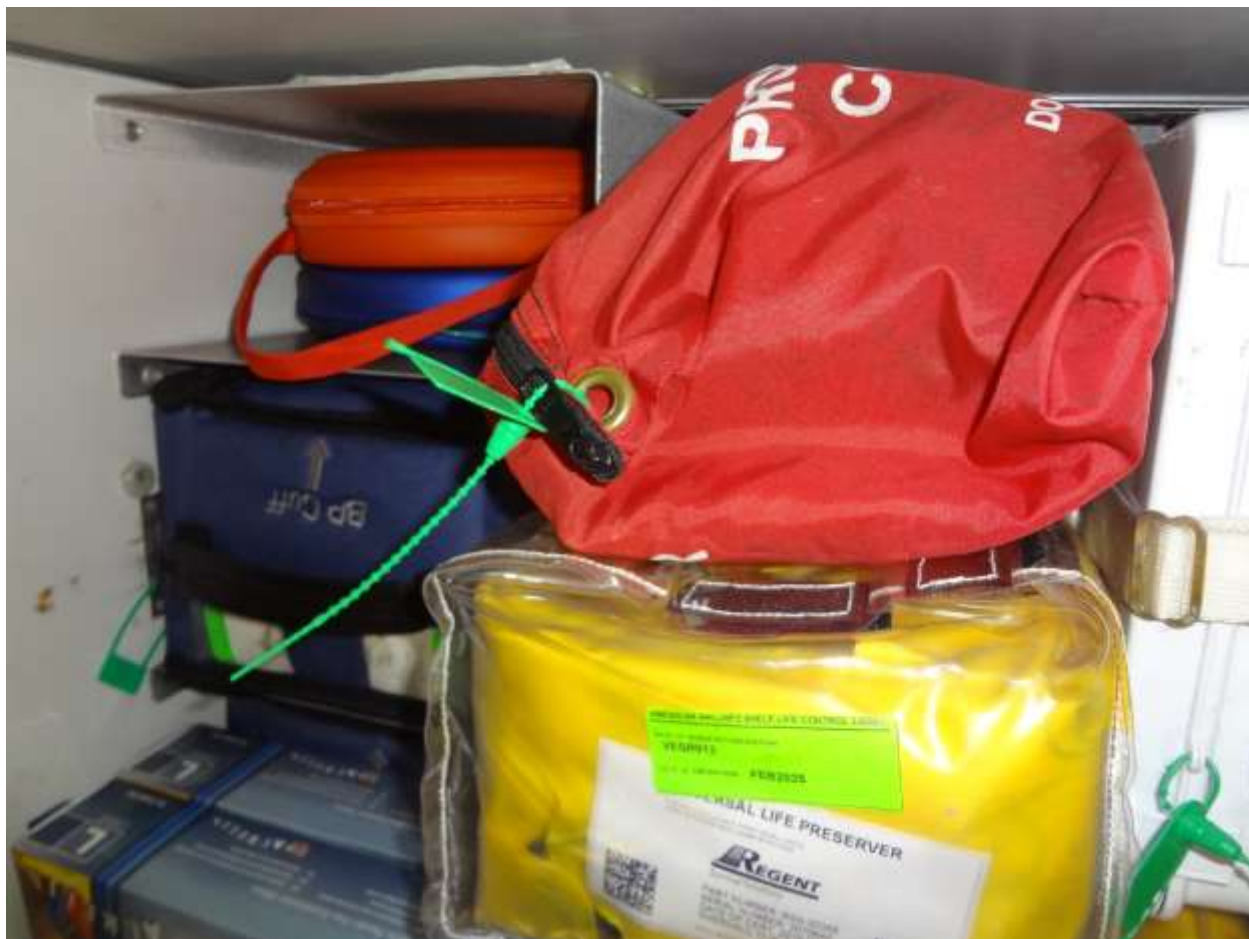
Photo 9: Cabinet as first viewed when cabinet door was opened (OPS Group Chairman)

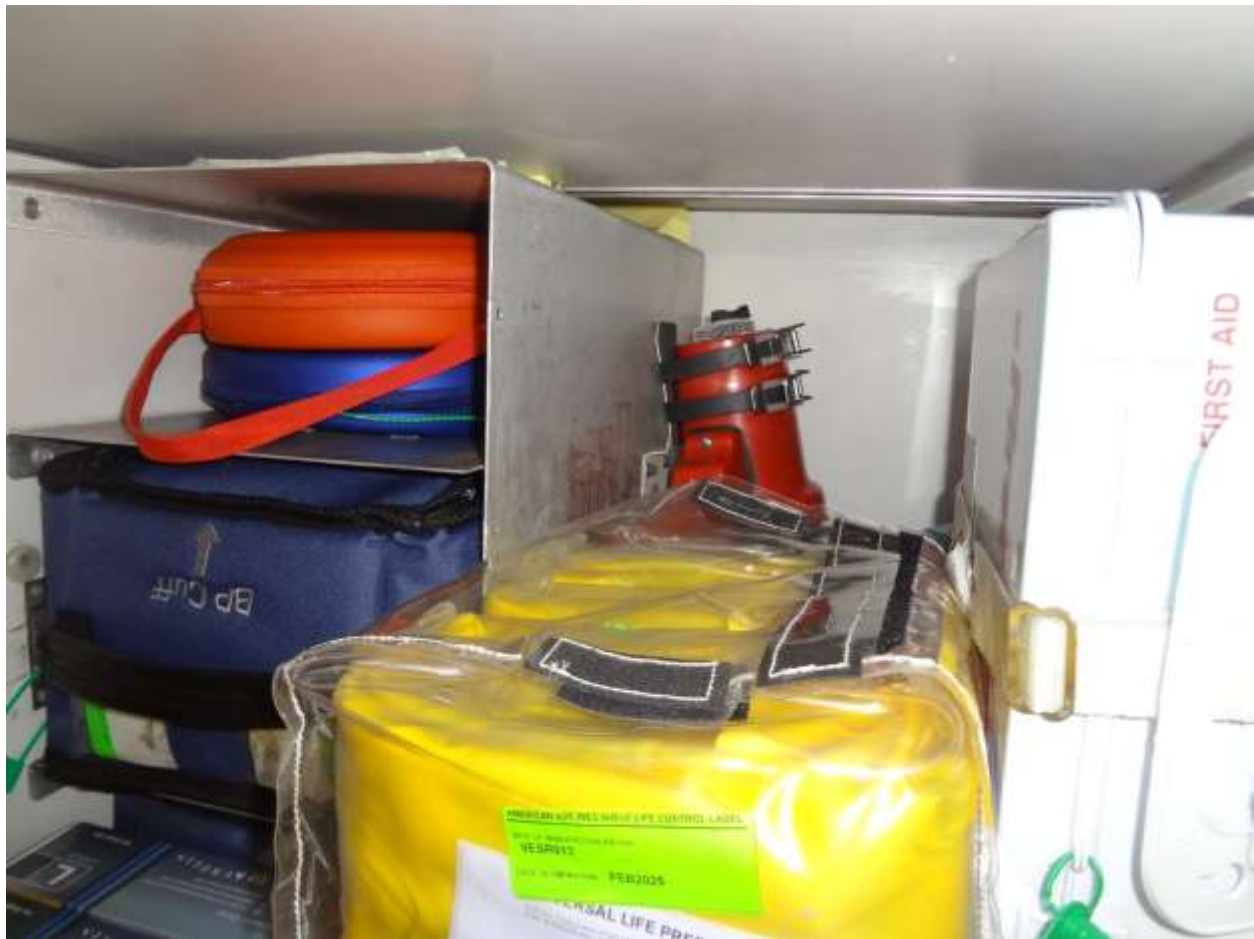
Photo 10: Megaphone Mounted within the Cabinet (OPS Group Chairman)
